**Steven Winter Associates, Inc. Building Systems Consultants
307 7th Ave. Suite 1701 New York, NY 10001**

**The Lenox
Telephone: (212) 564-5800
Website: www.swinter.com**

Results of Ventilation Retrofit by Remediation Specialists, Inc.

7/18/2011

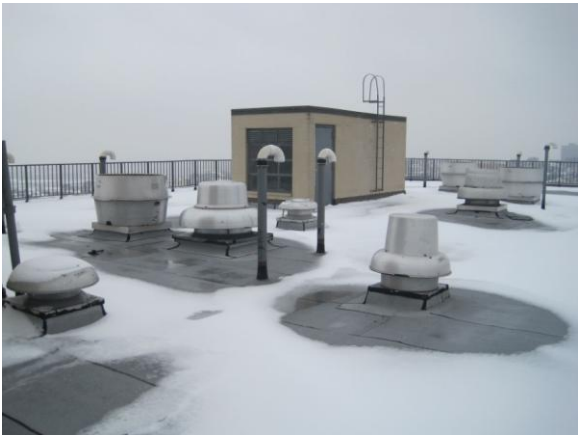
At the start of the project, 16 of the 44 roof fans, over one third, were not functioning. About ¼ of these had broken belts while the rest had more serious issues such as missing motors, missing fan parts, or wiring problems.

Roof exhaust fans. Note un-melted snow at non-working fans.

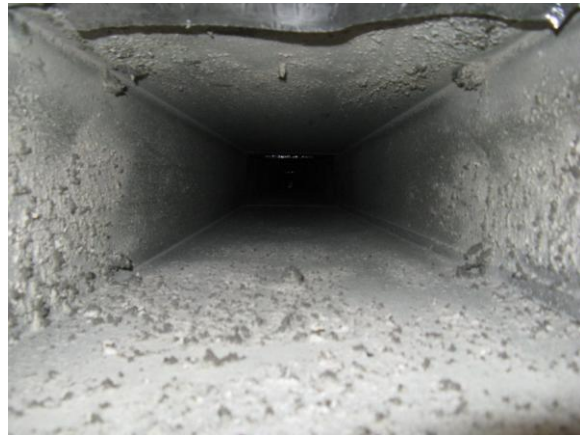
Kitchen riser before cleaning.

Cleaning of the risers involved visual inspections of all shafts using a camera to identify problems such as major debris that could impede the passage of cleaning and sealing equipment. Once all major debris had been removed, all registers were sealed with tape and a powerful vacuum was connected to the duct at the second floor. A cleaning nozzle was then lowered down the shaft. Compressed air flowing through the cleaning nozzle causes rubber tubing connected to it to whip around vigorously. As the nozzle is lowered down the duct these whips dislodge accumulated dirt which is then collected by the vacuum at the bottom and top of the duct.

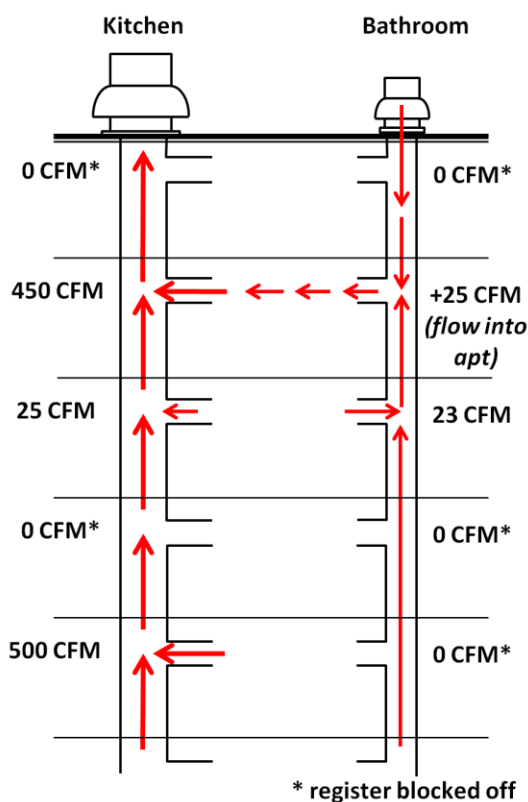
Airflow Patterns in Malfunctioning Ventilation Systems at the Lenox

So extreme were the imbalances of this system that odd airflow patterns resulted. One bathroom exhaust fan was not working correctly, so its defunct shaft became a transfer pathway for airflow and smells from other apartments and even from the roof.

exhaust fans was so extreme, the broken roof fan serving the bathrooms had in effect become a supply fan, pulling air from outside. As a result of the noise and other objectionable operations of the exhaust systems in these apartments, most residents had blocked their ducts off completely. Those that hadn't experienced either low exhaust rates or even reversed airflow into their apartments.

The figure to the left conceptually shows a common scenario in a poorly-sealed ventilation system at the Lenox. Though it is possible to precisely measure exhaust flows at registers in each apartment, a great portion of total building exhaust is missed. For example, when one encounters a register that a tenant has blocked for one reason or another, the measured flow is zero, while leaks behind

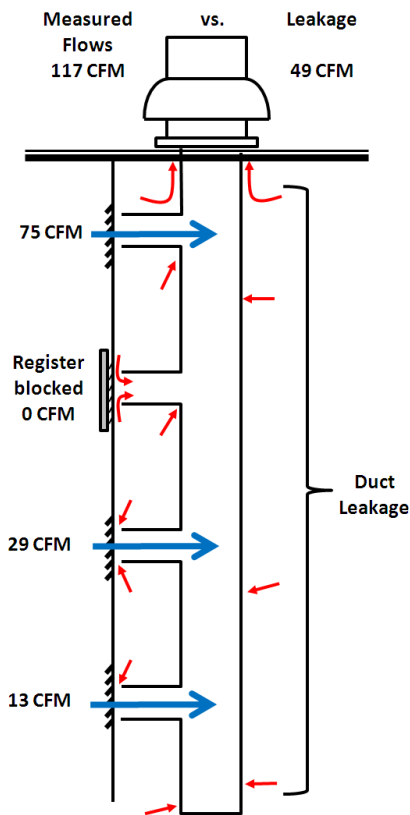
Leakage Points in a Poorly Sealed Duct System

the register may be a significant airflow. Added together, the leaks in an exhaust system may represent a significant portion of the total ventilation load and while this exhaust flow is practically useless to indoor air quality, it still uses energy.

Many of the Lenox's exhaust systems are therefore quite good at ventilating wall and ceiling cavities, but terrible at delivering exhaust where it is actually needed. Leaks in some are so bad as to be detectable within the apartment. In one apartment on the 2nd floor of the building, airflow being drawn from the wall cavity by a leaky duct was so great that 13 CFM exhaust was measured through a light switch, more than 100 feet from the fan.

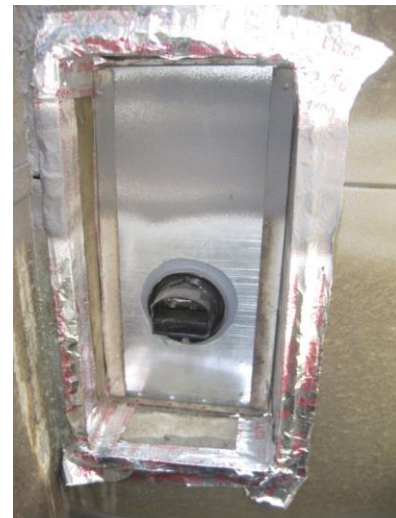
View from inside duct of sealed take off joint.

Prior to installing dampers RSI also cleaned and sealed the joint between the short take-off duct and the main vertical riser. This joint is often a source of significant leakage and is relatively easy to seal. The joint was sealed using UL-181 rated tape.

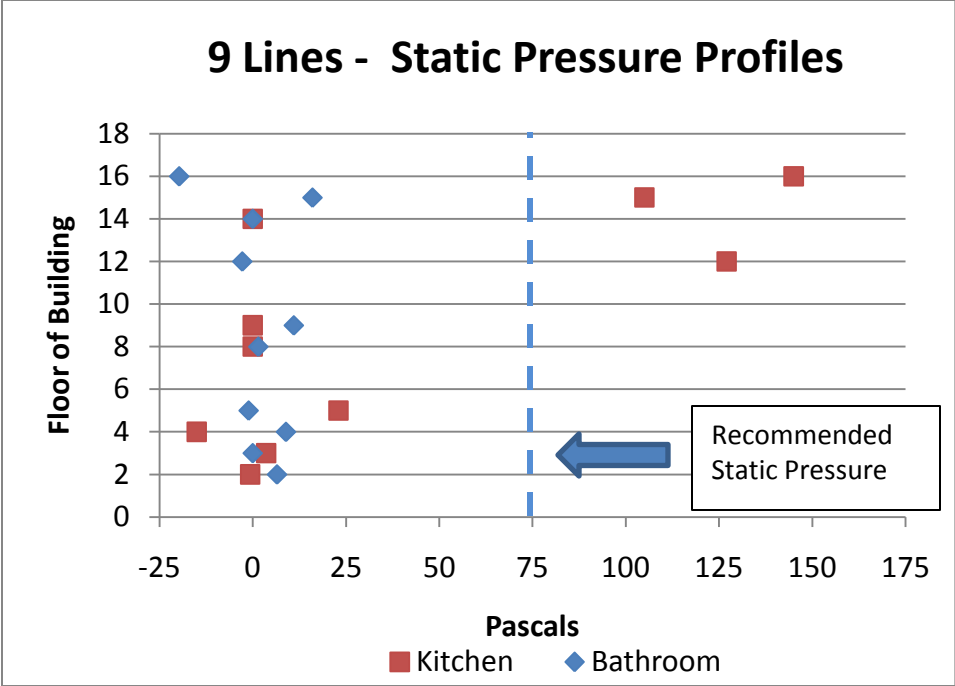
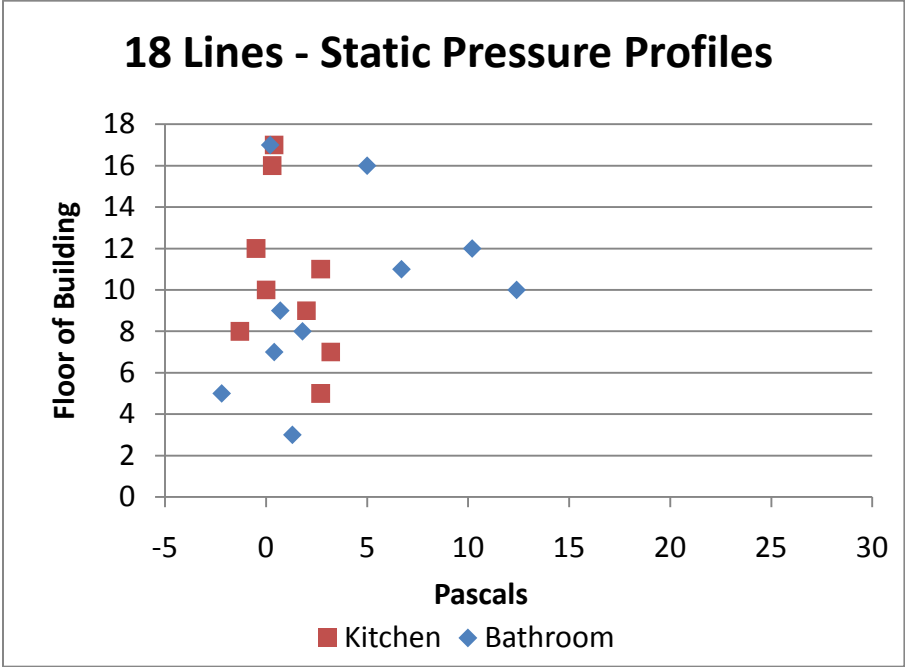
In the ventilation scheme using CER dampers, a static pressure of 75 Pa or more is needed to properly operate the devices. Of the 48 registers at the Lenox where flow was measured only three had static pressure high enough to operate CER dampers.

Judging from the graphs below, one can see that the balance in single lines was very poor. A well-balanced and sealed ventilation system would have a more vertically-aligned profile of static pressures. The ideal (difficult to achieve in real practice) is indicated by the dotted line in the chart of pressures from 9 Kitchen and 9 Bath below. Obviously there were serious problems with balance in the kitchen lines, with some registers exhibiting very high static pressures while others showed very low or even negative pressures. The 18 Kitchen and 18 Bath lines are similarly imbalanced. One reason for these stark imbalances is modifications that tenants have made to the ventilation by taping and otherwise blocking off registers in their apartments, but the underlying cause of their modifications was frustration with the poor performance of the systems to begin with.

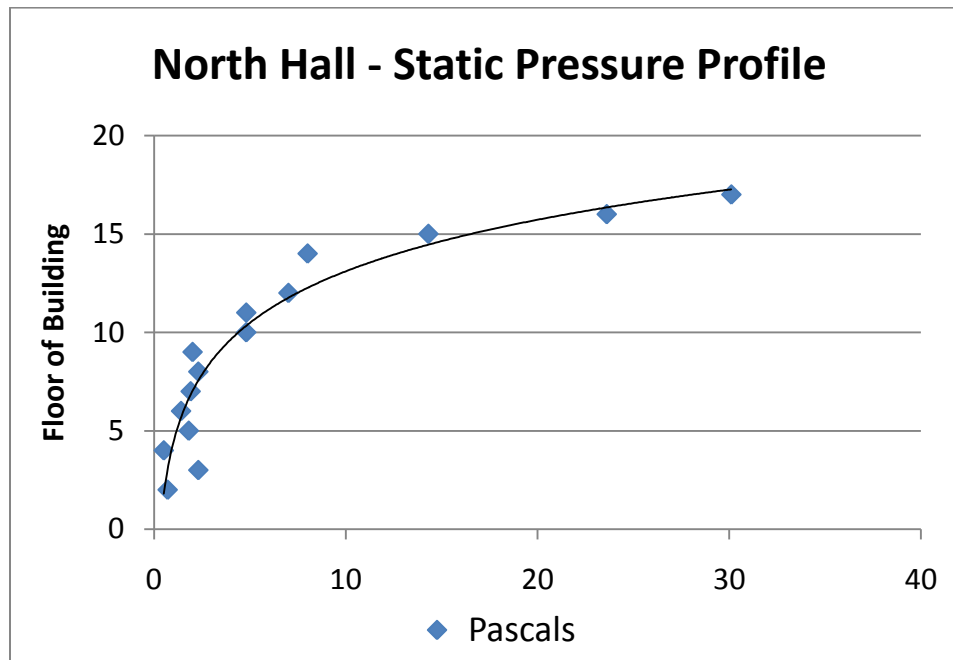
Though it was not included in the retrofit, static pressure and flow was measured at the North Hallway exhaust registers, mostly because the data from these systems would be easy to obtain and analyze. The static pressure profile for the hallway exhaust line follows a pattern that is very much expected for a ventilation system in a high rise building which is unaltered from its original design. The pressures fit a logarithmic curve essentially as expected, with much higher static pressure at the top of the riser decreasing at regularly smaller intervals on lower floors. The hallway systems were designed much like the kitchen risers, with large ducts and large register openings. The open areas of the registers are too large to allow the system to ever develop sufficient static pressure for proper operation; the result is extremely high flows on upper floors and very poor flows on lower floors.

Average: 7 Pascals

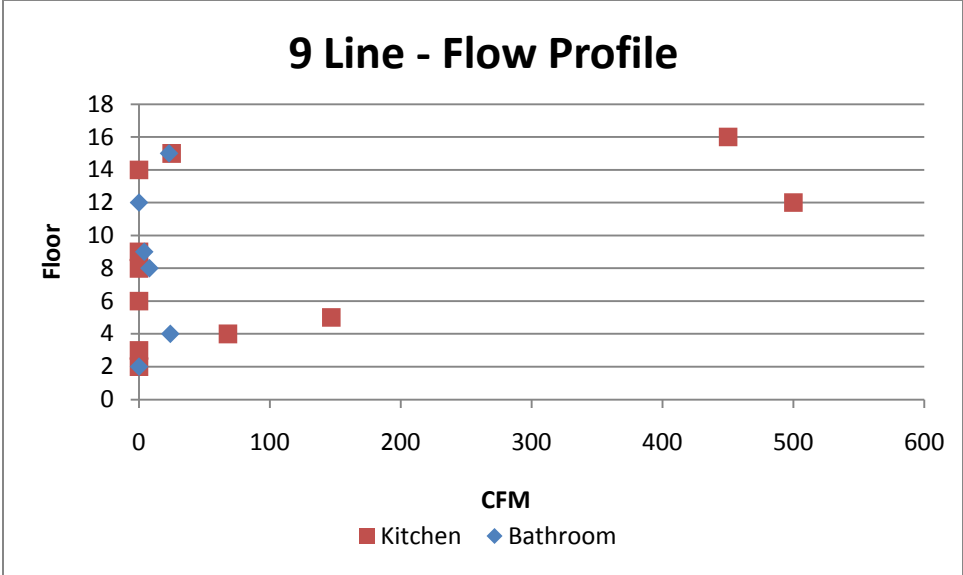
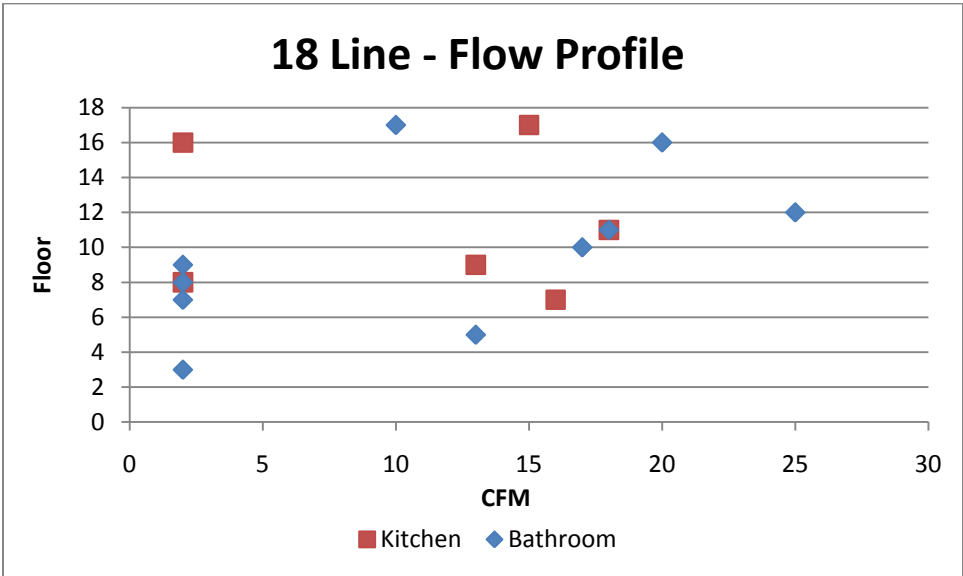
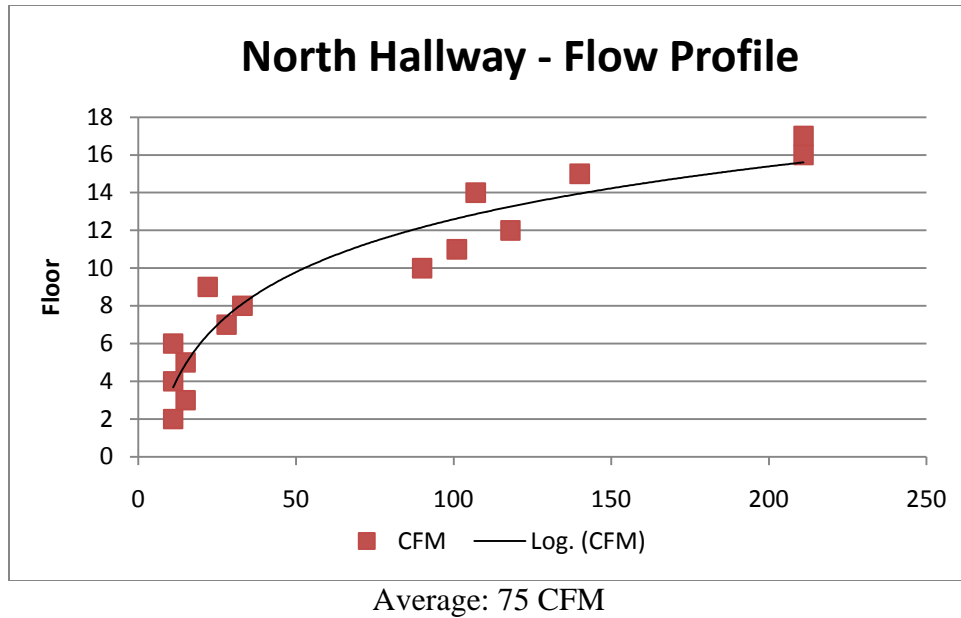
Flow is obviously a very important metric for evaluating a ventilation system. As expected from measurements of static pressure, the measured flows were inconsistent and generally very low. The apartment risers had much more irregular flows. The 9 Kitchen riser had two registers with over 400 CFM of flow and several with no measurable flows because they were blocked off. The 18 Kitchen riser had much lower flows overall, with none of the measured registers above 15 CFM. The North hallway had a flow profile more typical of a lengthy vertical duct run, with high flows at the top that gradually decrease to essentially zero flow at the bottom. This is essentially how most of the risers in the building would look if they had not been altered from their original designs.

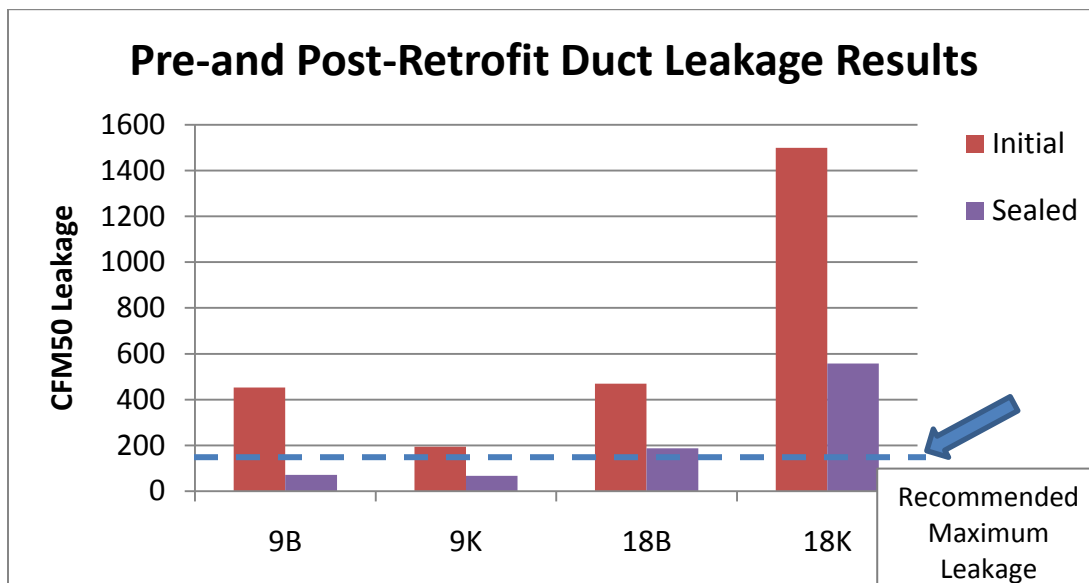
Before the retrofit, 4 of 4 shafts were above the maximum leakage level recommended for good ventilation operation, while after the retrofit, 2 of 4 of the shafts were. Though the obvious goal is to get every shaft below the maximum recommended level, one must consider the starting point for each of these shafts. The 18 Kitchen shaft, for example, has more than 3 times the recommended maximum leakage after the retrofit, but before, it had almost 10 times the recommended level.

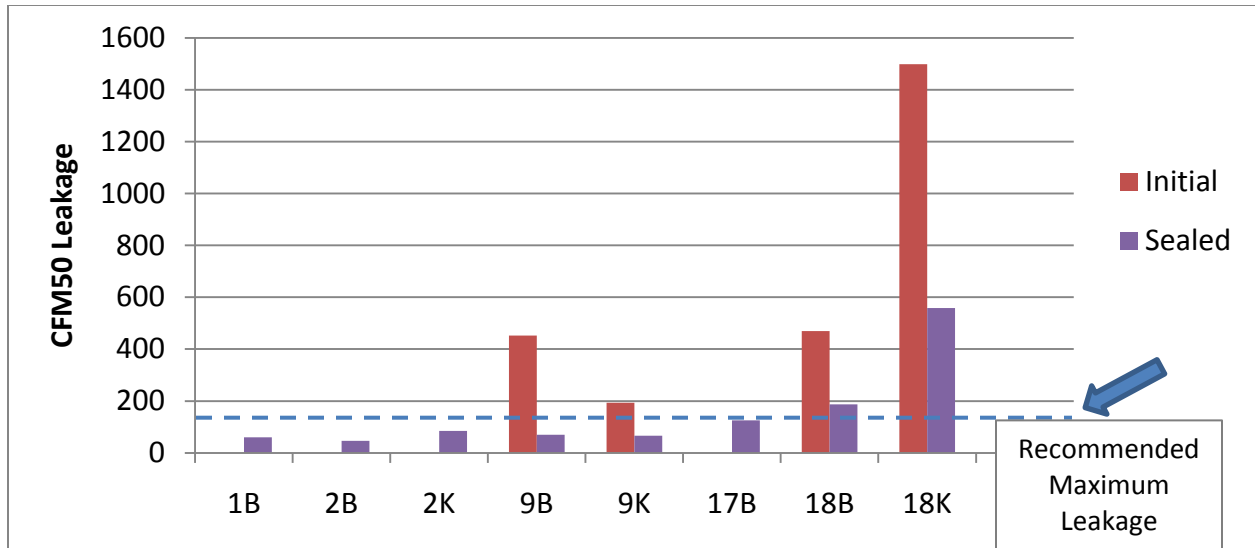
RSI chose these four shafts for the improvement potential they expected to realize, and given the post-retrofit results, one should say that they were each a success. Put in the context of other shafts tested after the completion of the project, these “trouble” shafts are standouts among many other well-performing examples. The chart below shows post-retrofit results from four other shafts, and all these were below the recommended maximum leakage level.

Shaft 18 Kitchen was found to have major ductwork issues at every floor. RSI constructed special takeoffs and ductwork for each unit in this line, and these efforts were likely largely responsible for the massive reduction in leakage.
