Photos of Findings and Fixes During the Central Exhaust Shaft Weatherization Process

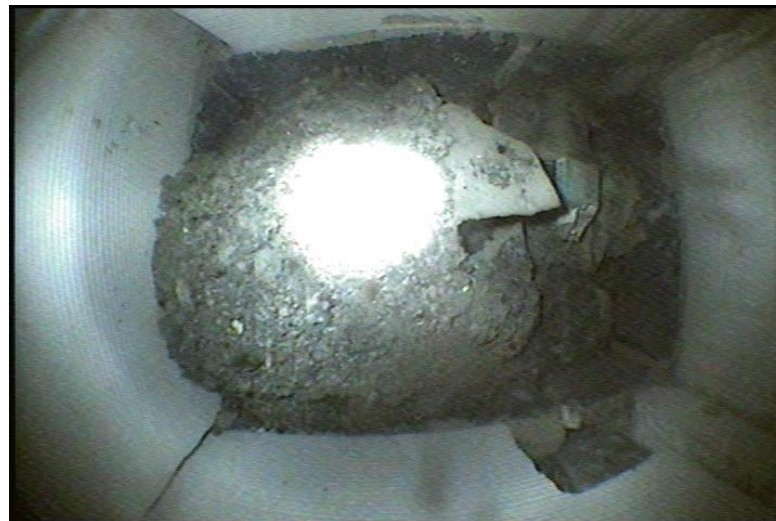
Dirt & Debris

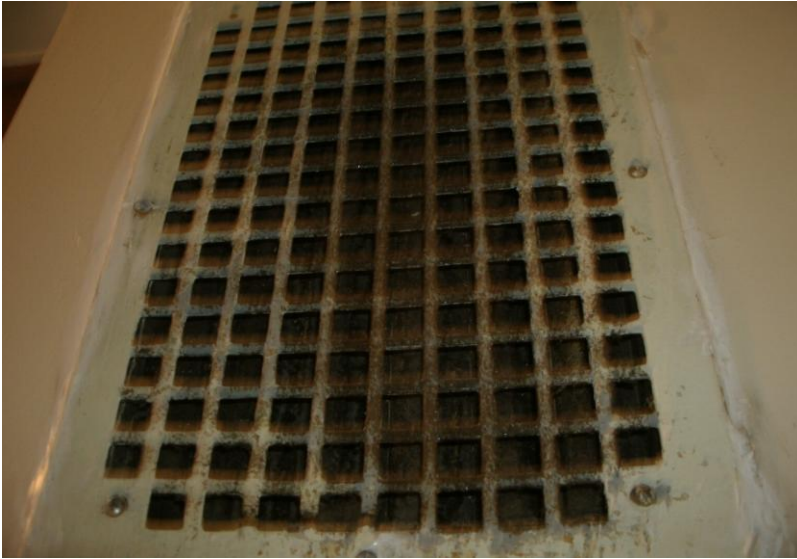
Dirty Vent

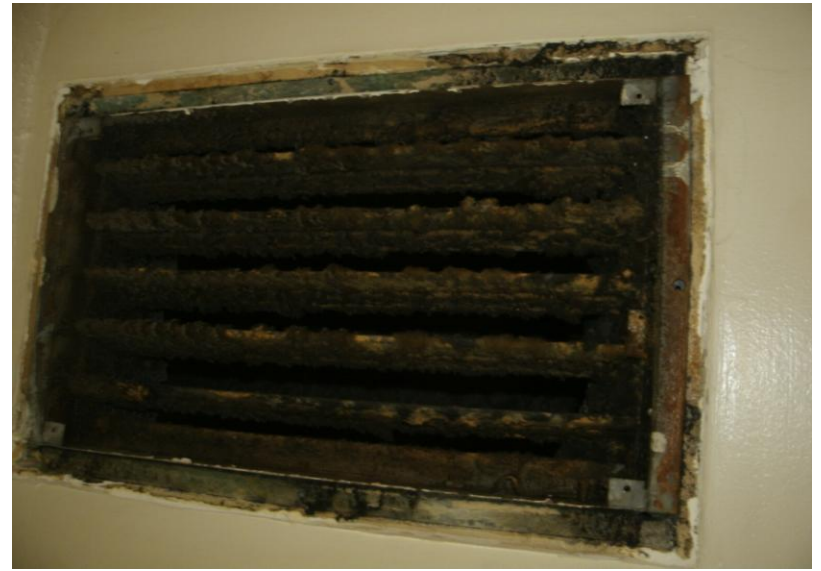
Dirty Damper

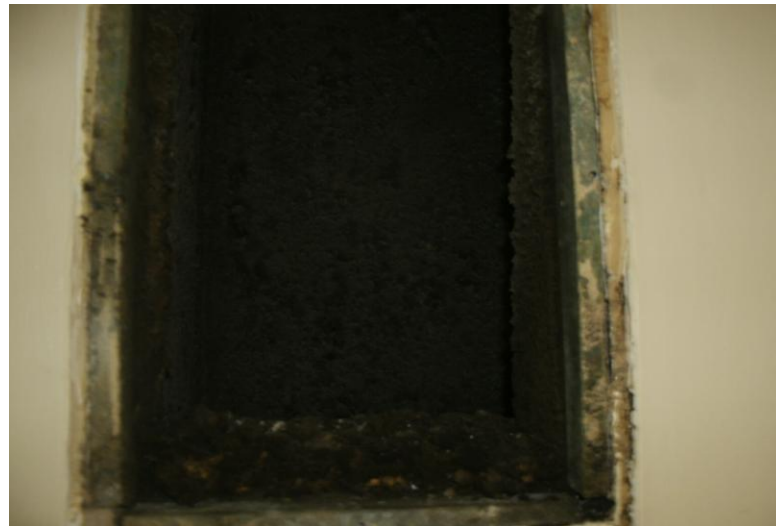
Dirty Boot

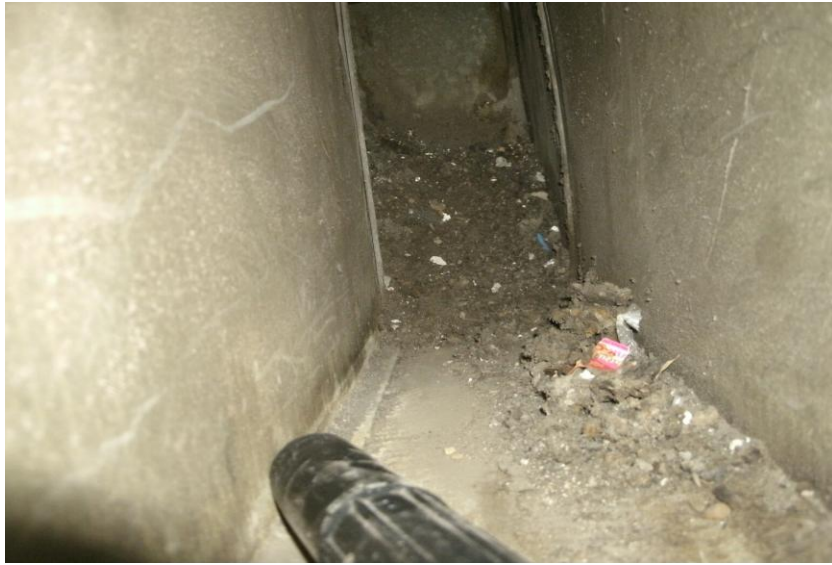
Dirty Vent Lateral at Bottom of Shaft "Before"

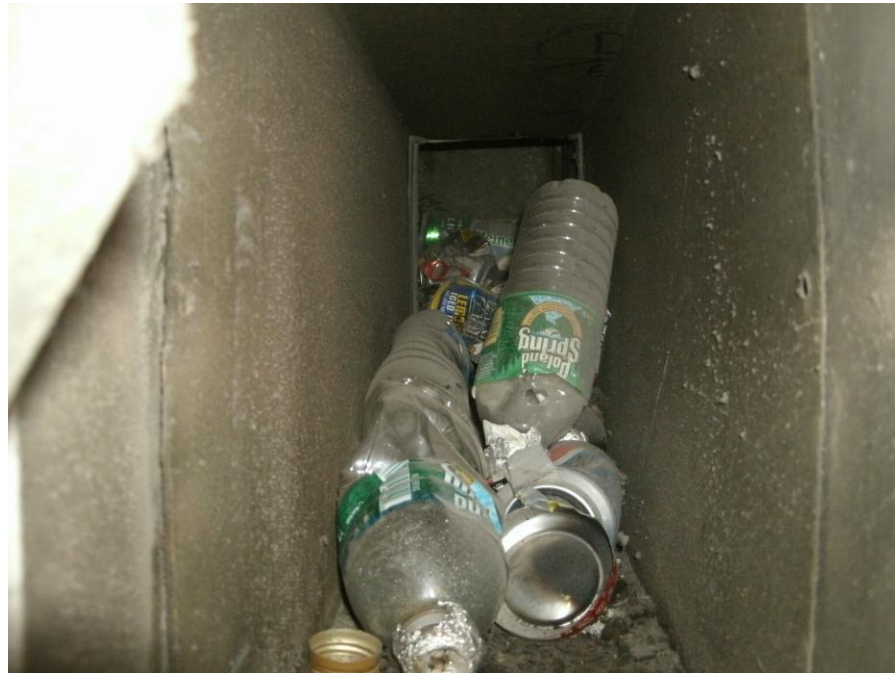
Exhaust Shafts are Often used as a Convenient way of Disposing of Debris During Construction

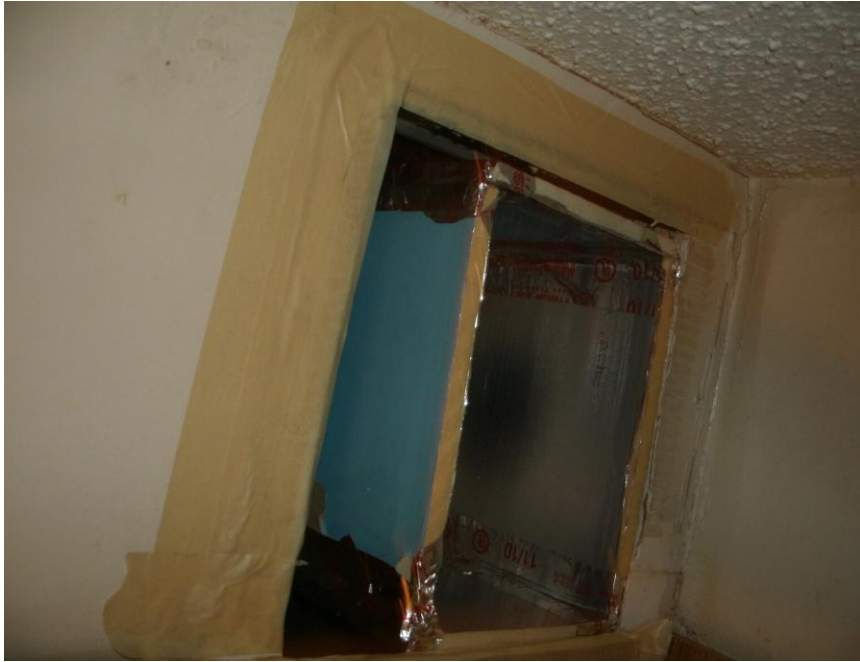
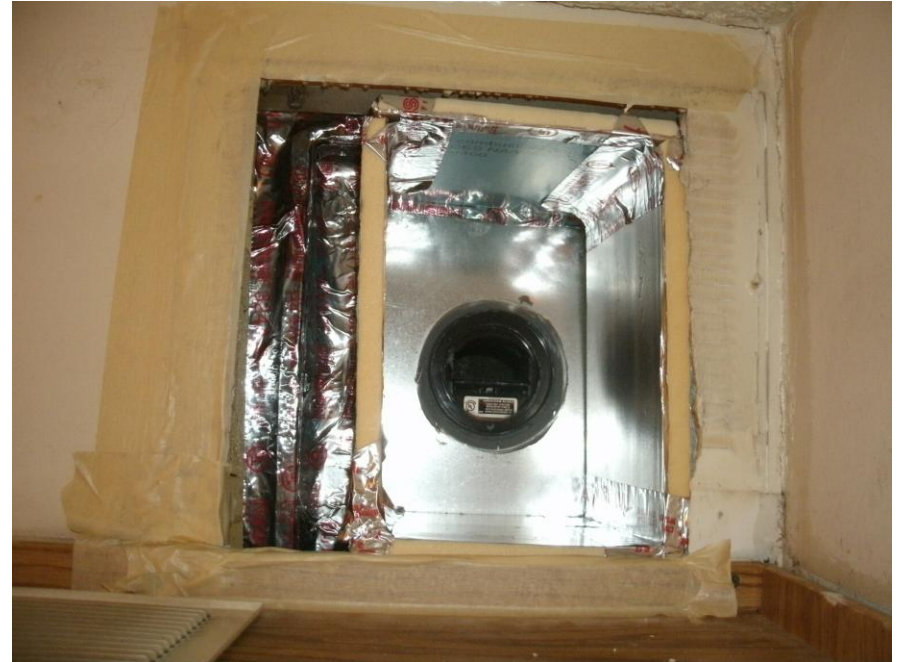
Large Vent Cut into Wall Complete Disconnect from Main Exhaust Shaft Had to be Boxed in then sealed

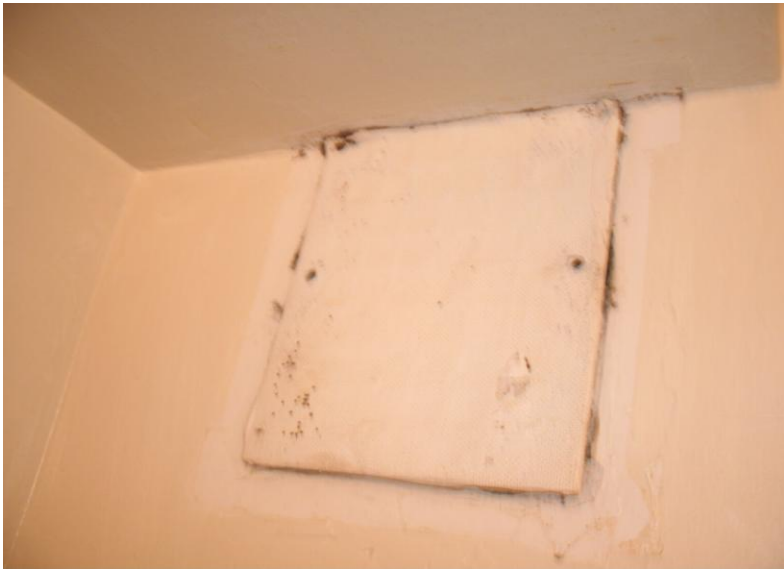
Tenant Blocked Vent

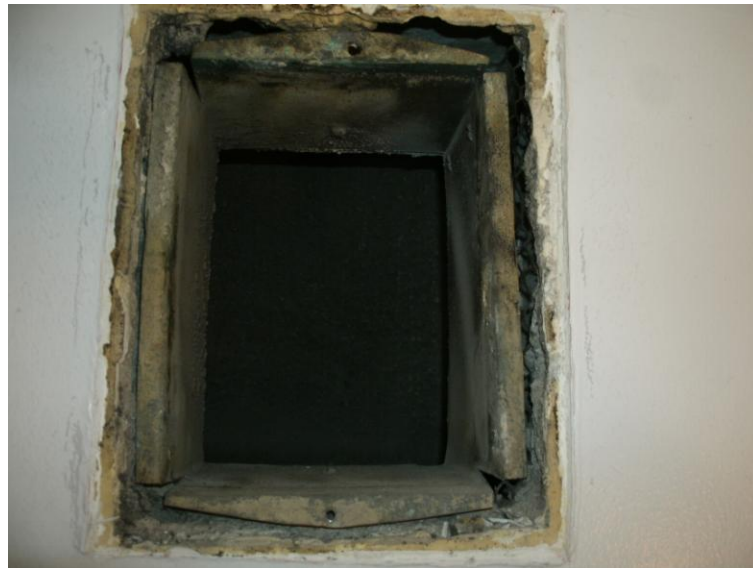
Large Gaps Around Vent Boot

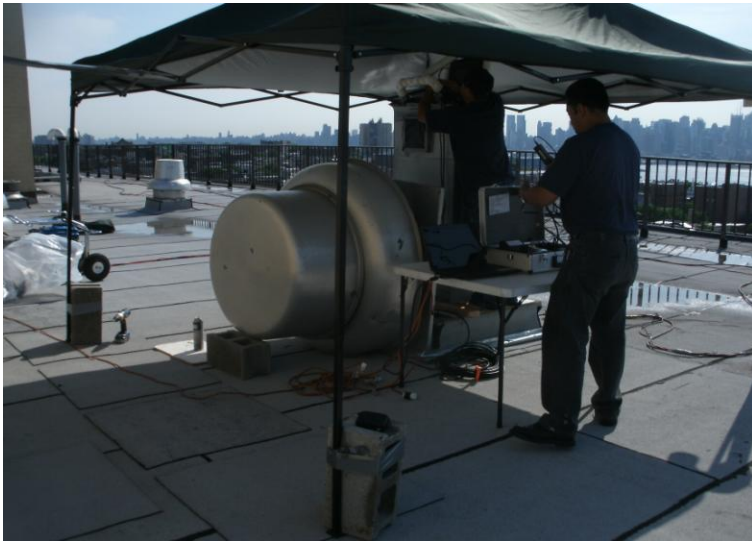
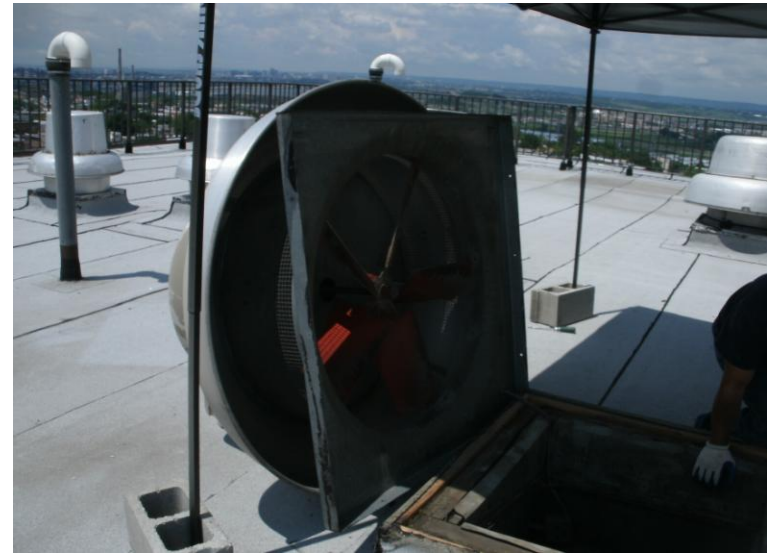
Fan Removed, Setting Up Computer & Camera & Robotic Controls and Access / Control Ducting Installed

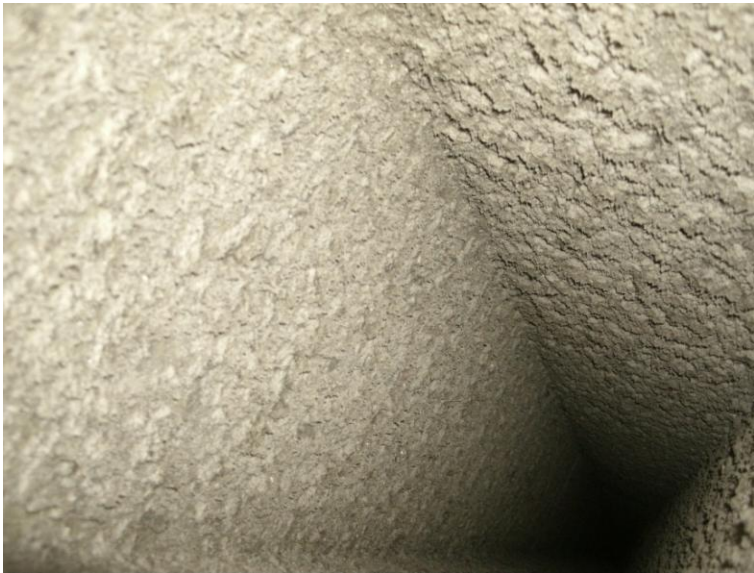
Very Dirty Shaft "Before" Cleaning

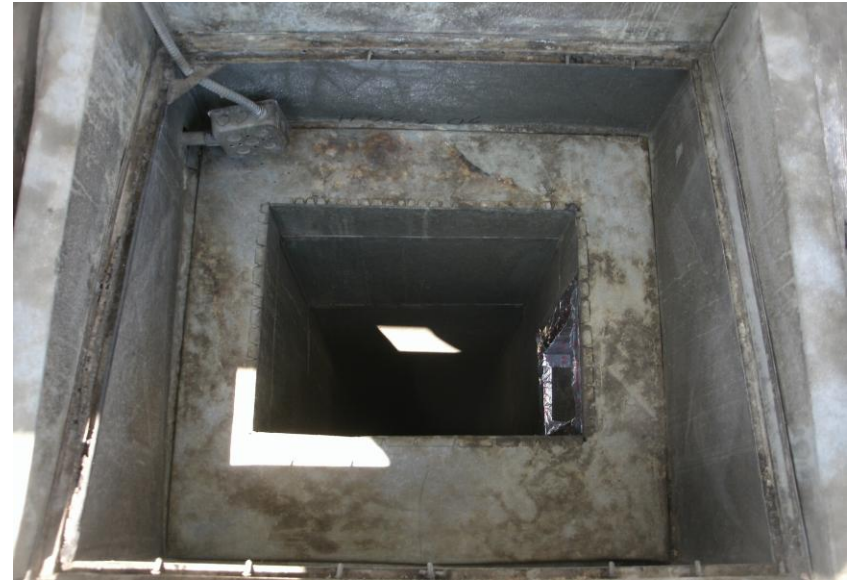
View Under the Fan "Before" Sealing
